INSTALLATION RESTORATION PROGRAM

SOUTH DAKOTA NATIONAL GUARD
JOE FOSS FIELD, SIOUX FALLS, SOUTH DAKOTA

SITE INVESTIGATION REPORT

February 1996

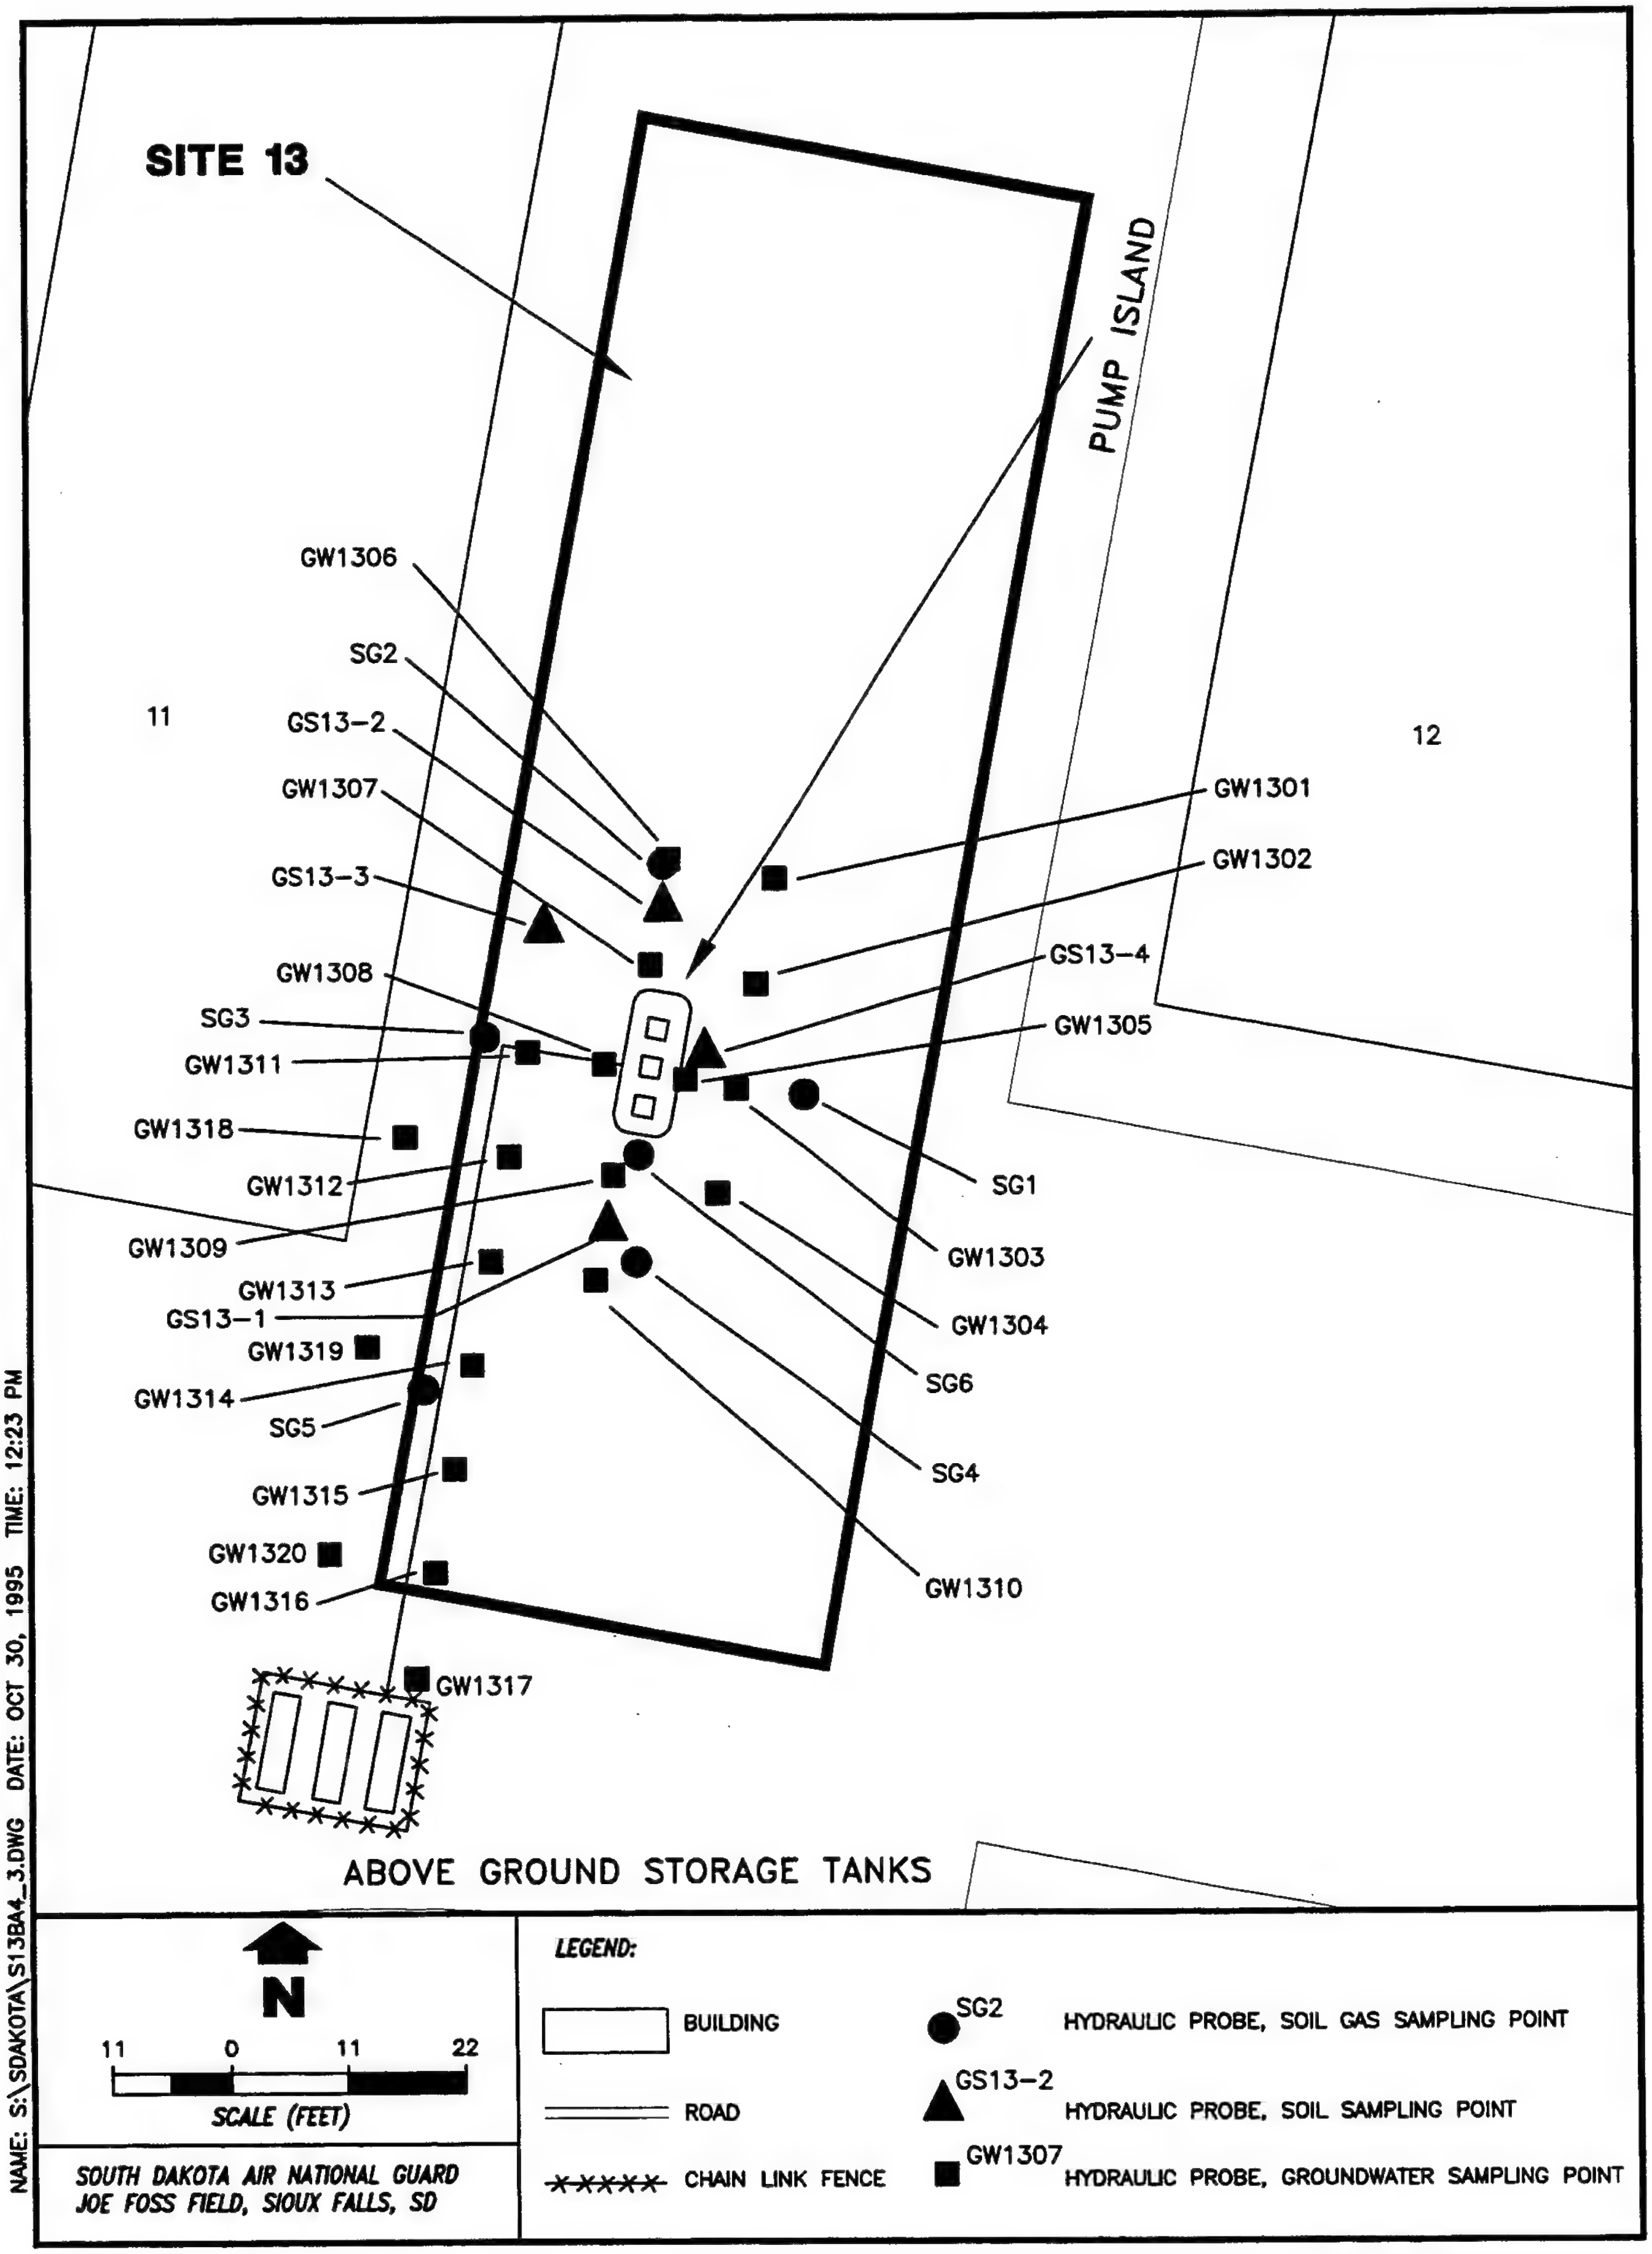
Figure 4-3. Field Screening Sampling Points at Site 13

Six SOV survey locations were established at Site 13, as shown in Figure 4-3. Four samples were collected at each point: one each at 2, 4, 6, and 8 feet BLS. Groundwater was encountered at approximately the 8-foot interval, which prevented SOV sampling beyond this depth. Four SOV points were arranged around the pump island (one each to the north, south, east, and west). A fifth survey point was located above the underground fuel lines that supply the pumps. A sixth survey point was located between the protective posts on the south side of the island, where odors were first discovered by construction workers digging the post holes. The SOV survey results are discussed in their entirety in Appendix A.

Twenty groundwater screening samples were collected and analyzed by the onsite laboratory for TPH, BTEX, and solvents. Groundwater sampling locations were established using a 10-foot grid system around the pump island and fuel lines, as shown in Figure 4-3. The hydraulic probe was used to insert a temporary well point whereby groundwater could be sampled. The groundwater analyses results at Site 13 are discussed in Section 5.2.3 and presented in Appendix A.

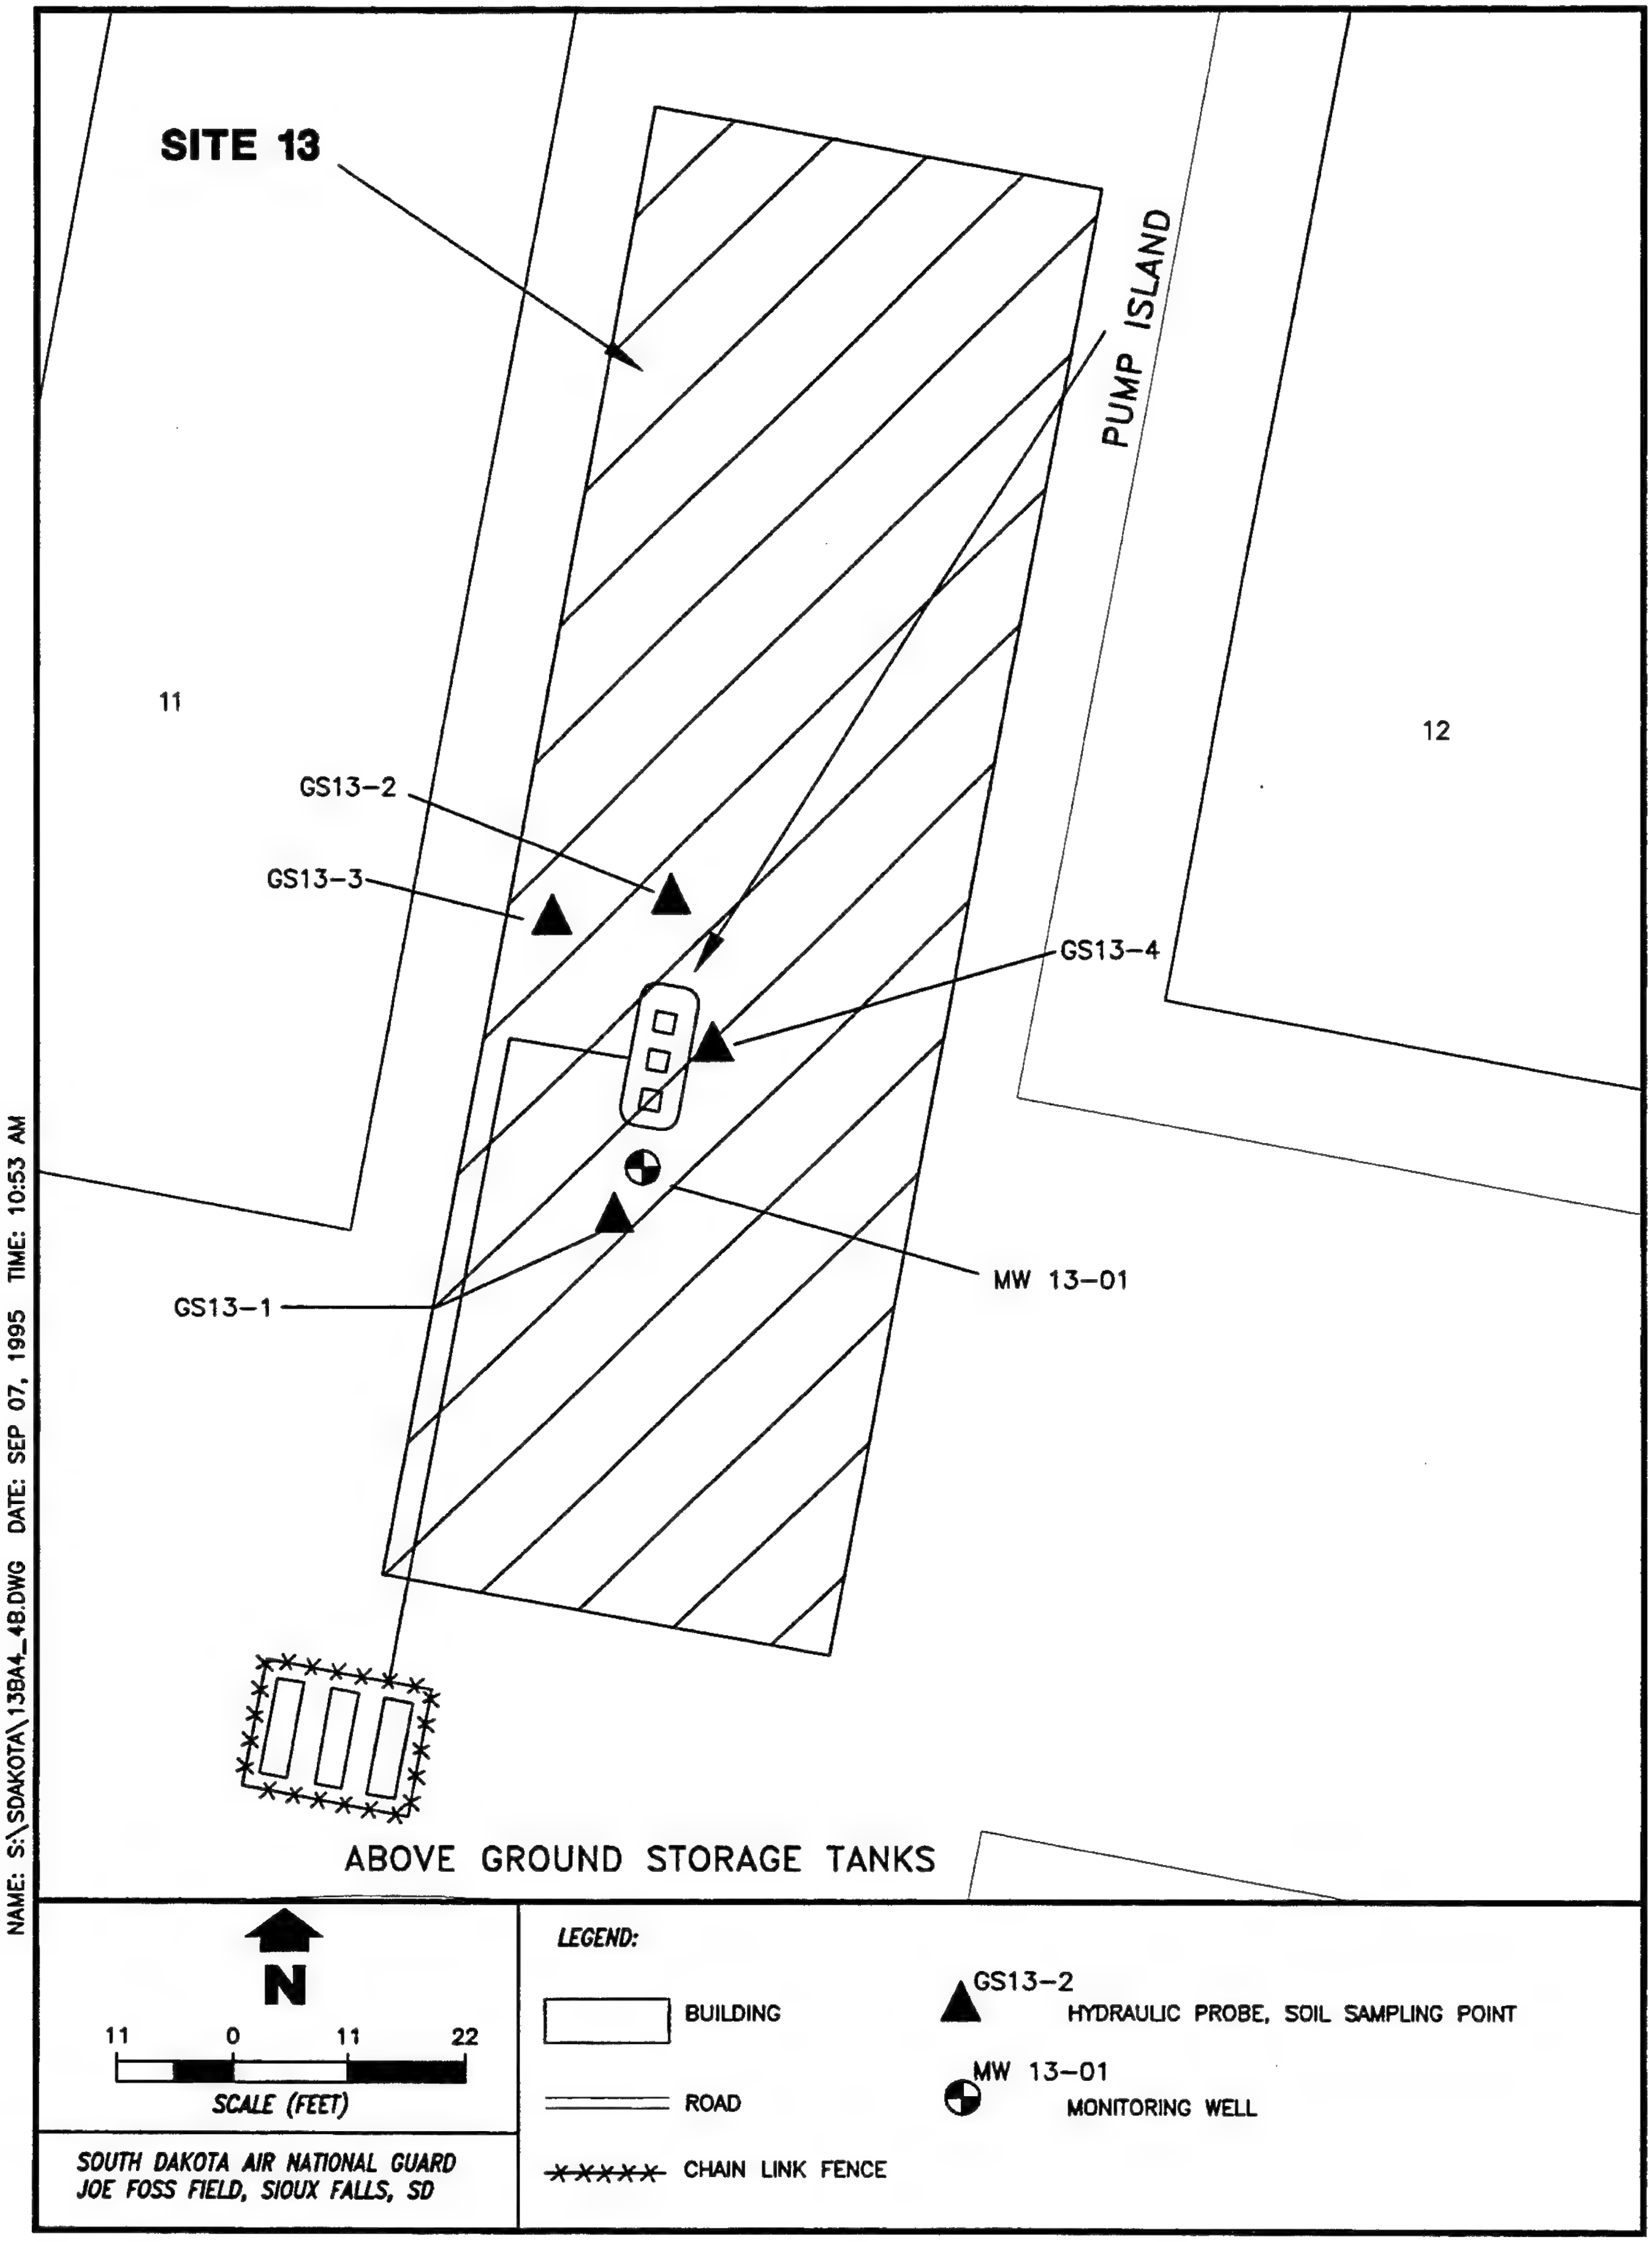
Figure 4-4. Sampling Points at Site 13

Based on the results of the SOV and groundwater survey, four soil sampling locations were chosen at Site 13, as shown in Figure 4-4. At each point, samples were collected at four depths: 3 feet, 3 to 5 feet, 5 to 7 feet, and 7 to 9 feet BLS. Groundwater was encountered at approximately 9 feet BLS in this area. Samples were not collected below the water table. Two sets of samples were collected: one for the onsite laboratory and one for the offsite laboratory. After the screening sample was analyzed by the onsite laboratory, two samples per location were selected for offsite analysis. Samples with the highest concentrations of contaminants at every location were analyzed by the offsite laboratory. If the screening samples did not exhibit contamination, the first and last sample intervals were sent for offsite laboratory analyses. A minimum of two samples per location (a total of eight samples) were sent for offsite analysis from Site 13. The soil analyses results are discussed in Section 5.2.2.

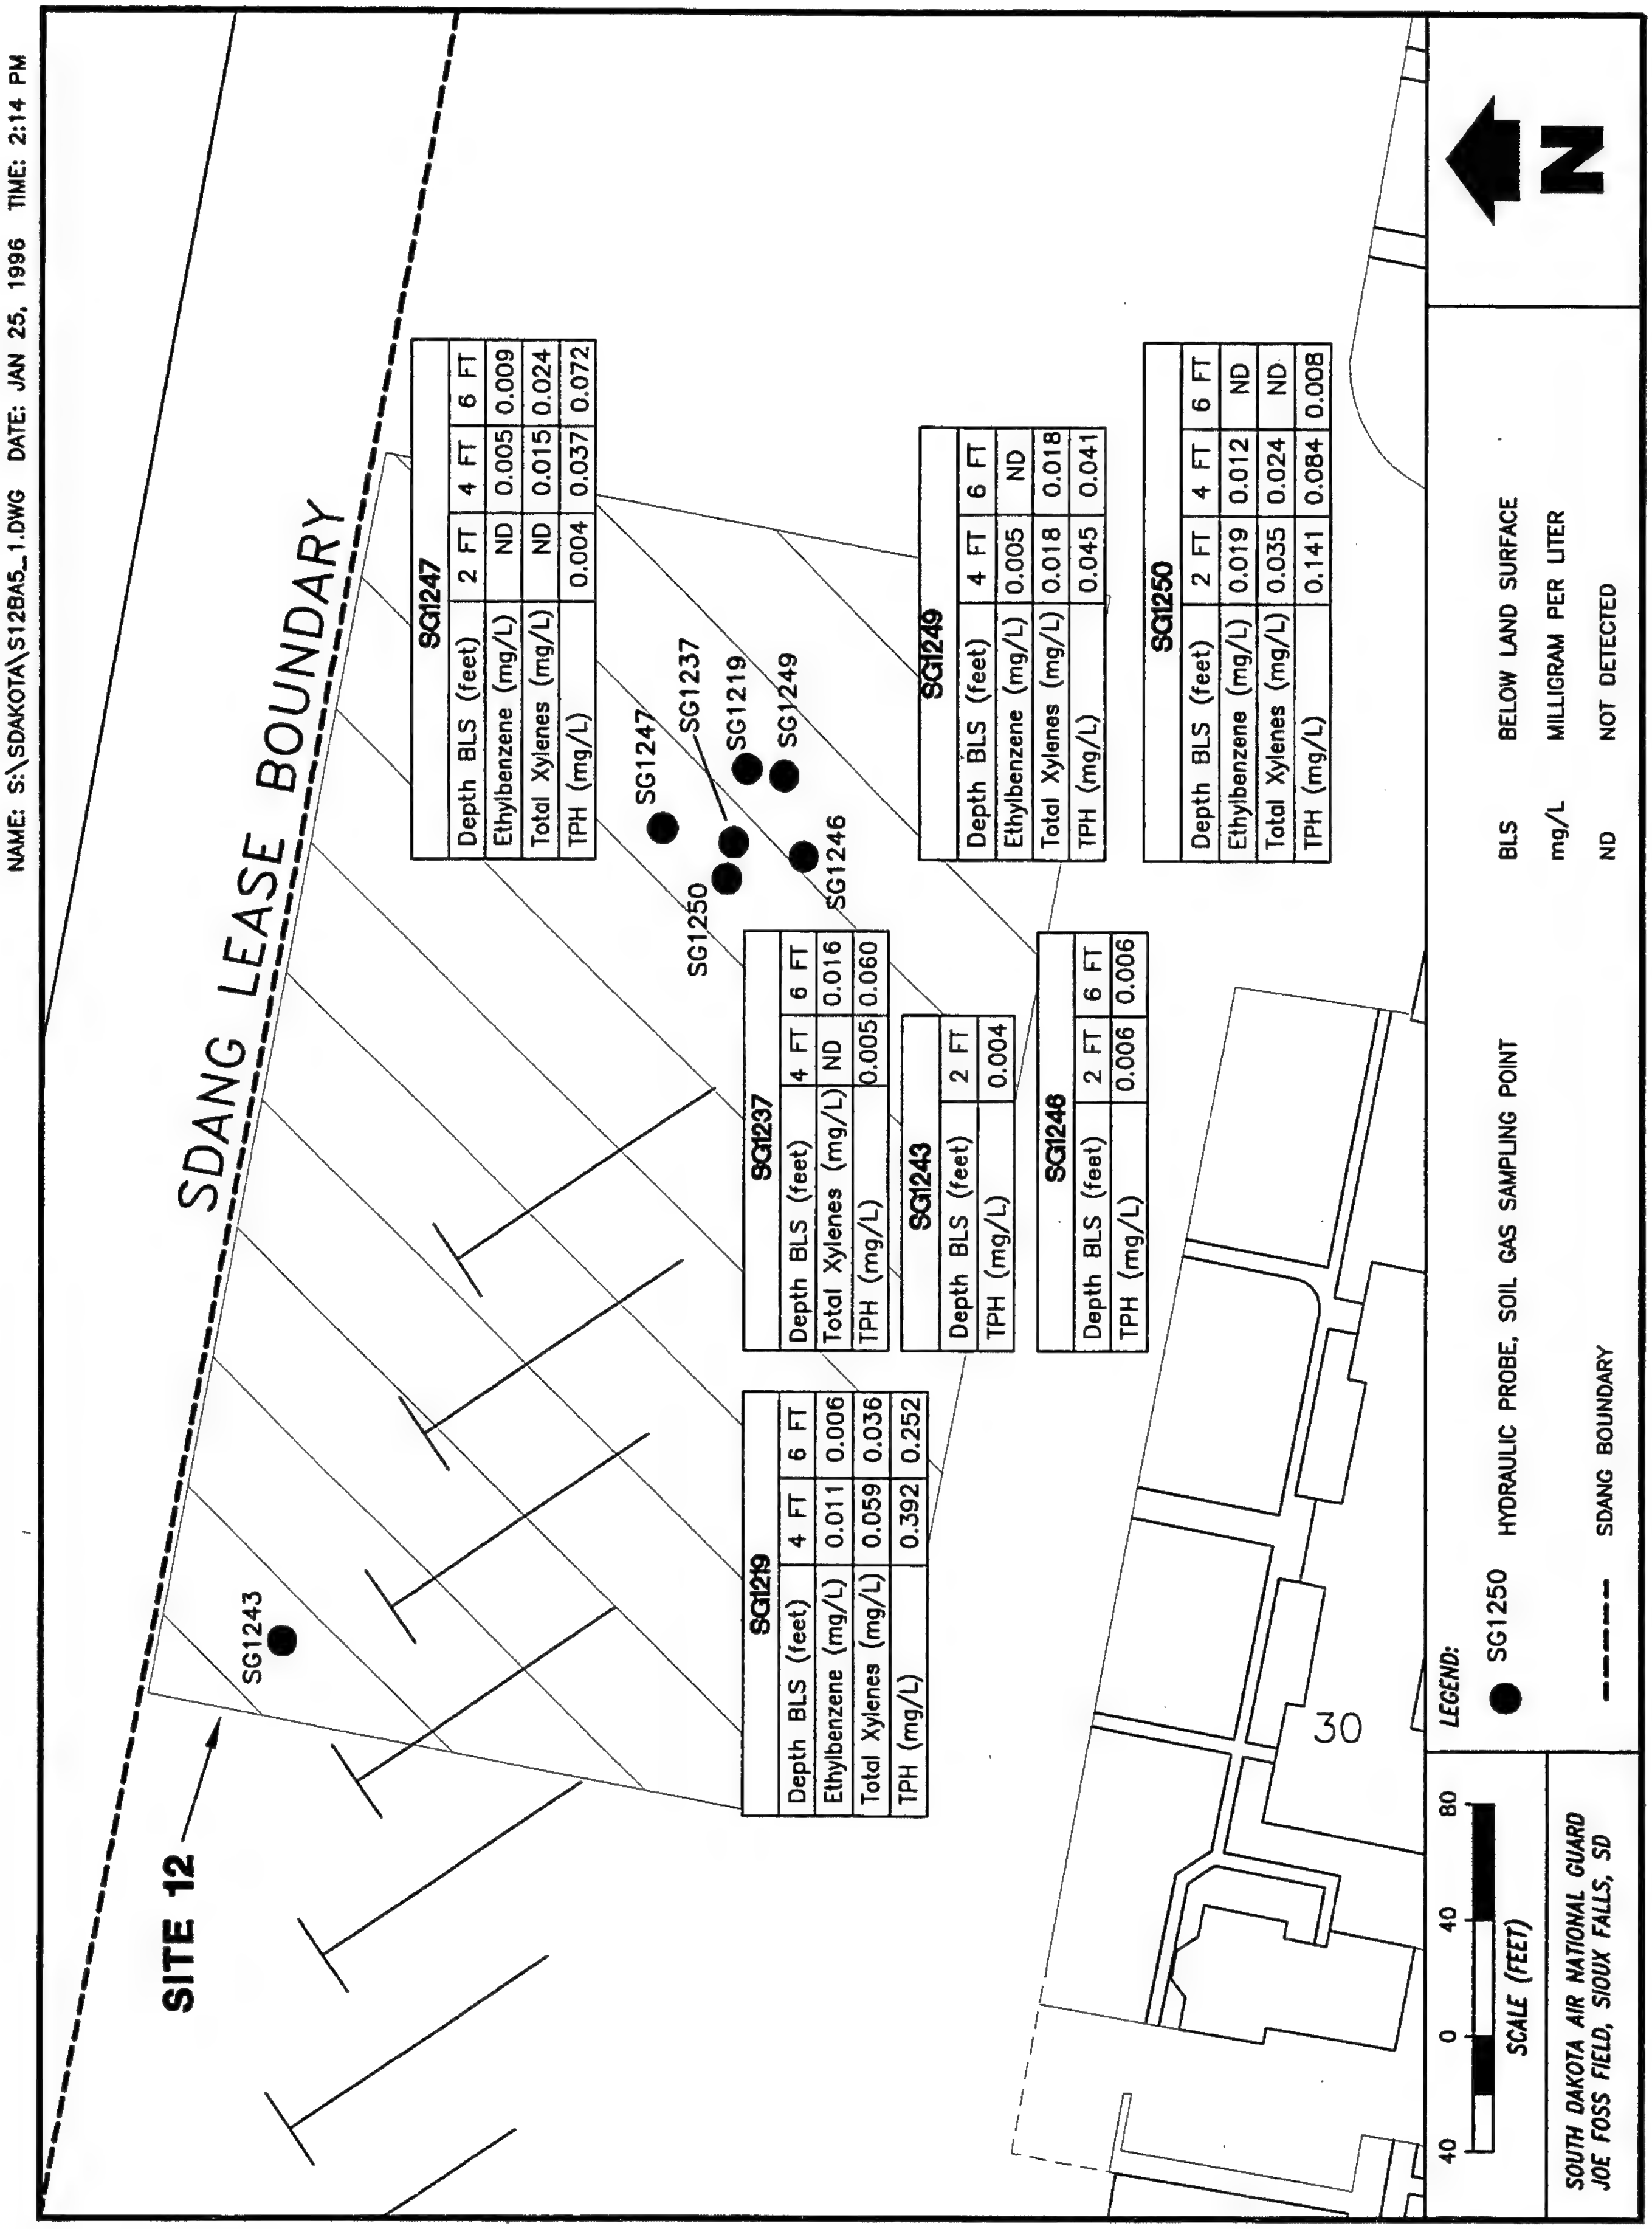
Figure 5-1. Summary of Site 12 Soil Gas Field Screening Results

TPH, ethylbenzene, and xylenes were detected in soil gas samples immediately east of Area 1. The maximum concentrations of these analytes were 391.7 micrograms per liter-volume (μg/L-v) TPH (4 feet BLS), and 59.2 μg/L-v xylenes (4 feet BLS). These maximum concentrations were all located at SOV point 19, approximately 50 feet due east of the Area 1 boundary, as shown in Figure 5-1. The maximum concentration of 19.37 μg/L-v ethylbenzene (2 feet BLS) was located at SOV point 50, approximately 12.5 feet due east of the Area 1 boundary. TPH and xylene contamination in soils, indicated by soil gas results, appears to be most widespread in the 6-foot sampling interval. No contaminants of interest were detected in

Depth BLS (feet)	2 FT	4 FT	6 FT
Ethylbenzene (mg/L)	ND	0.005	0.009
Total Xylenes (mg/L)	ND	0.015	0.024
TPH (mg/L)	0.004	0.037	0.072

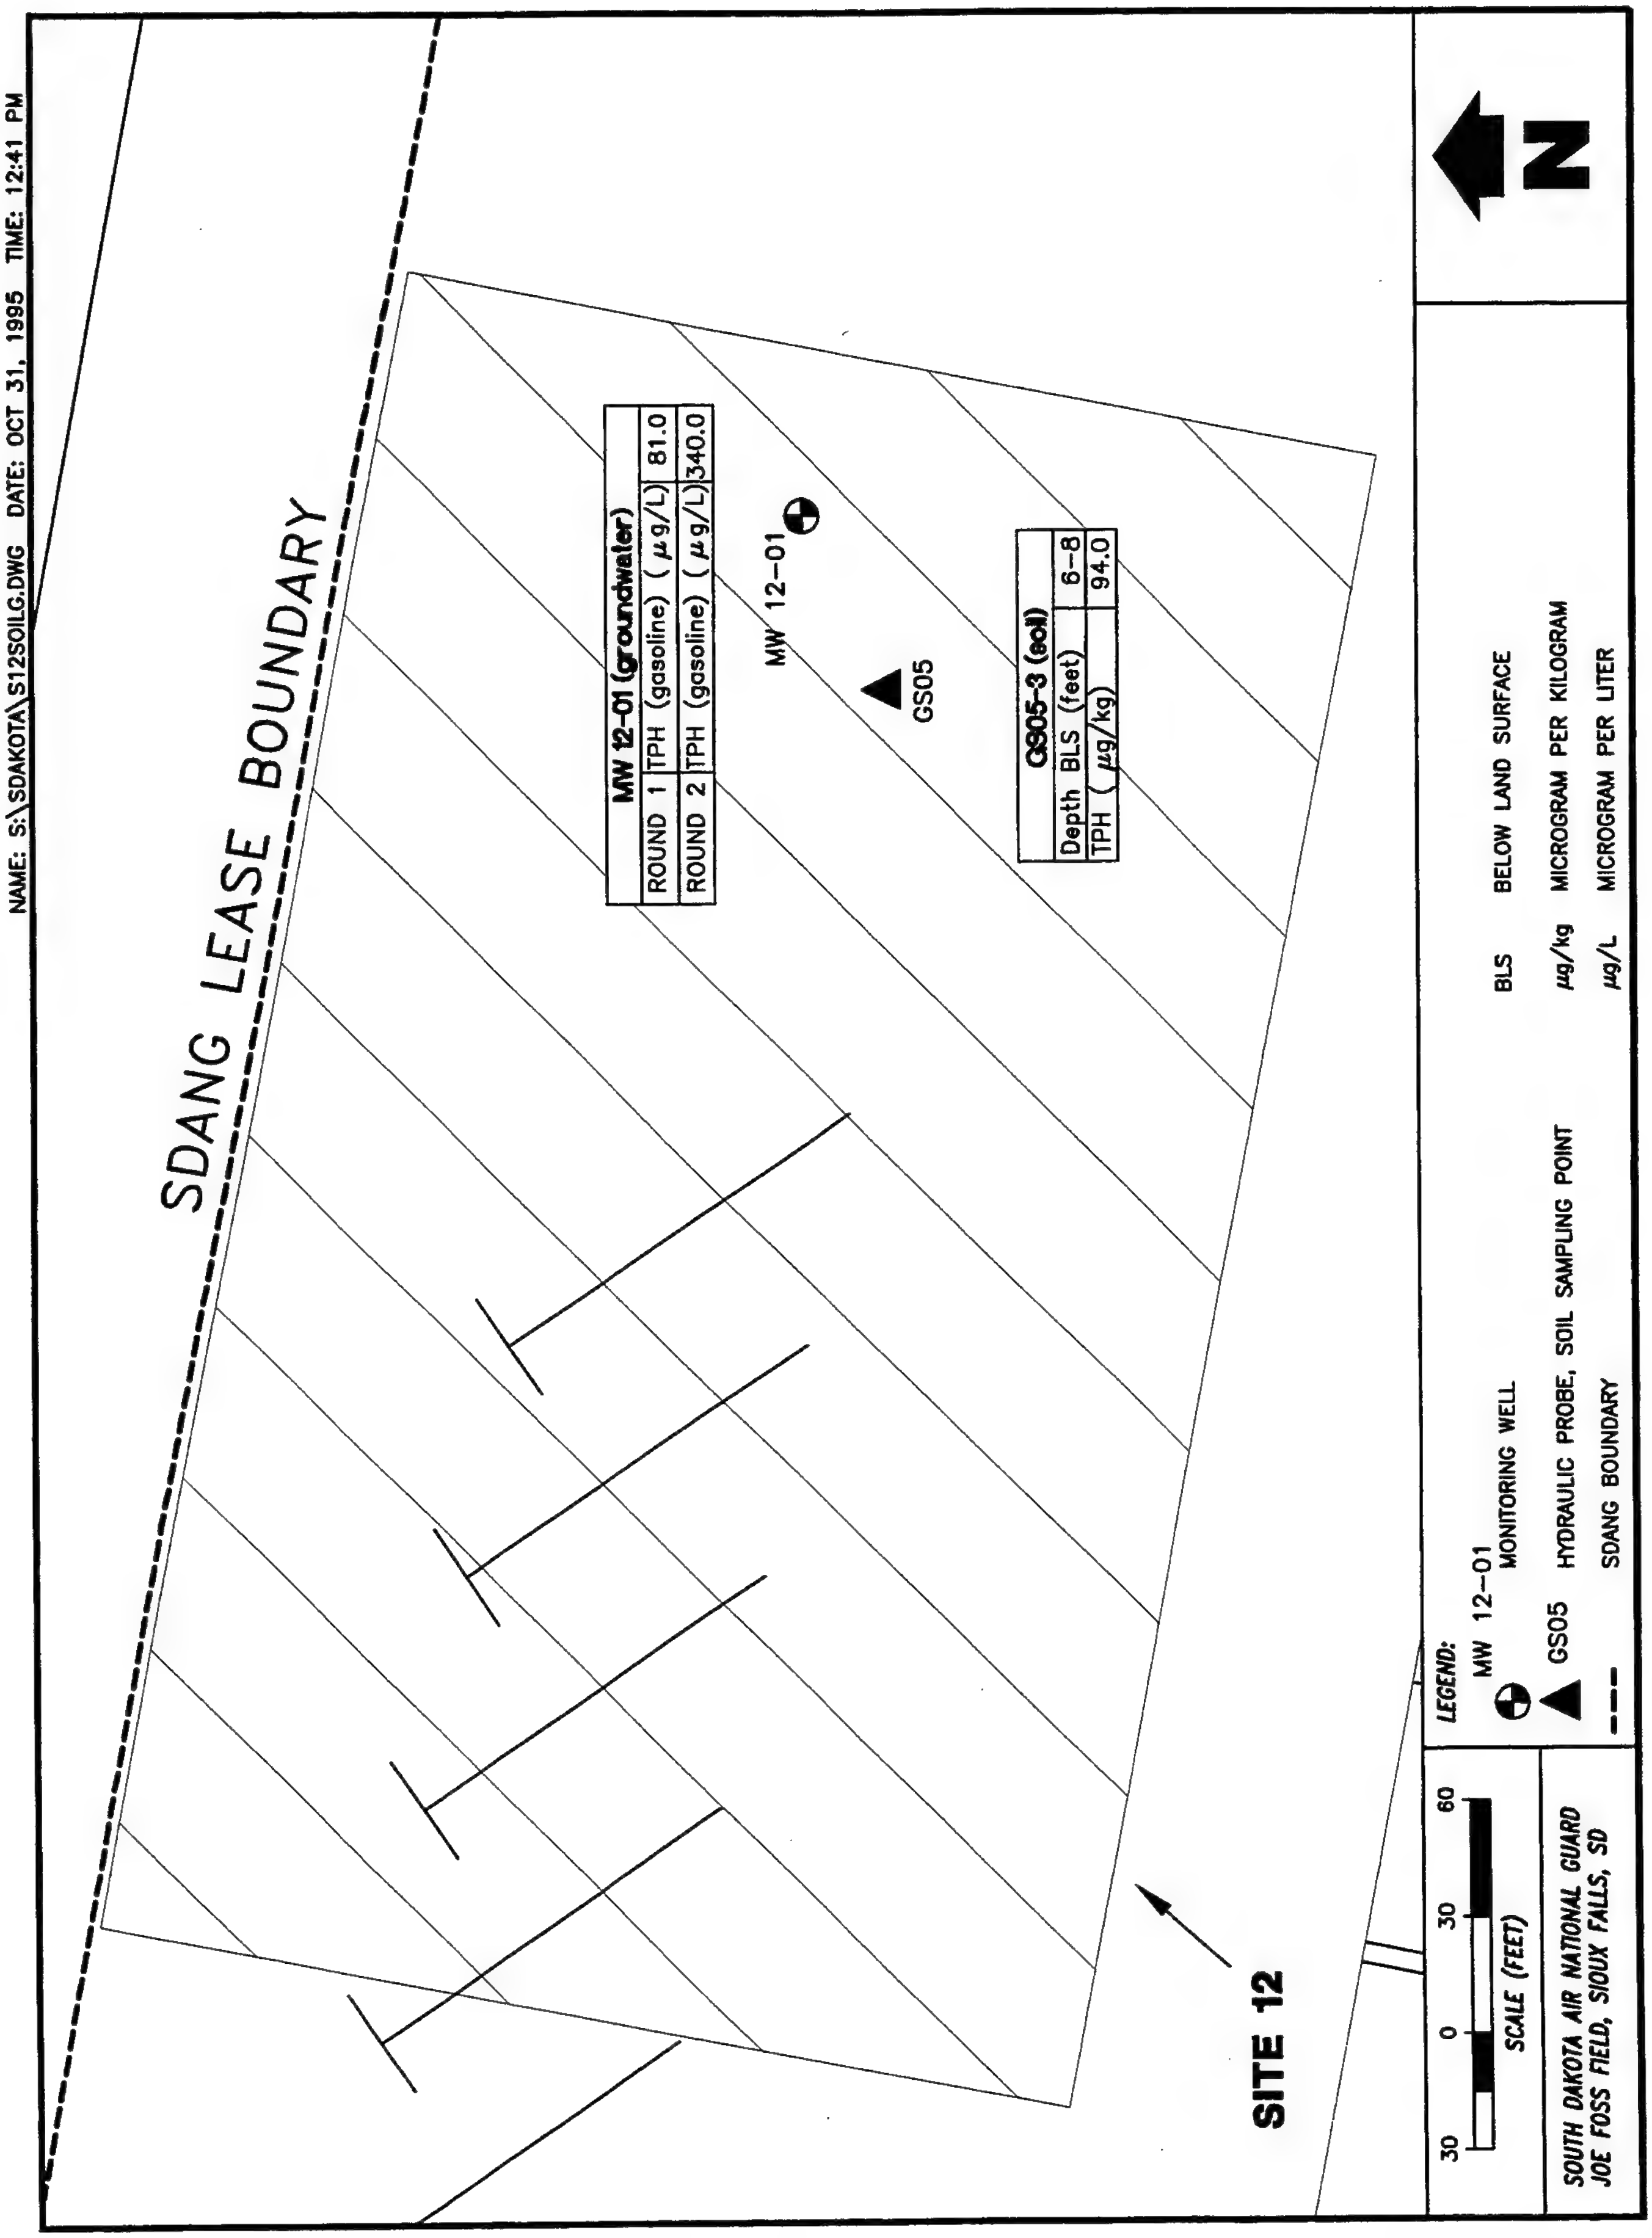
Figure 5-3. Summary of Site 12 Soil and Groundwater Results

Groundwater samples were collected from the five monitoring wells installed at Site 12 (MW12-1, MW12-2, MW12-3, MW12-4, and MW12-5). Samples were analyzed for BTEX and TPH. TPH as gasoline was detected at MW12-1 at concentrations of 81 μg/L, and 340 μg/L as shown in Figure 5-3. TPH or BTEX were not detected in any other groundwater sample. Table 5-4 summarizes these results.

The results indicate that contamination is present in the soils and that groundwater quality is locally affected. Therefore, it is recommended that the Air National Guard (ANG) continue groundwater monitoring on a quarterly basis. Groundwater samples were collected from Site 12 in June and July 1995. Three additional rounds of groundwater samples will be collected in February, May, and August 1996. The samples will be analyzed for TPH and benzene, toluene, ethylbenzene, and xylene (BTEX). Continued monitoring will expand the data set for groundwater at Site 12, allowing ANG to determine temporal and spatial variations in TPH concentrations. The data should allow ANG to evaluate whether soil contamination east of Area 1 impacts the groundwater sufficiently to warrant further study.

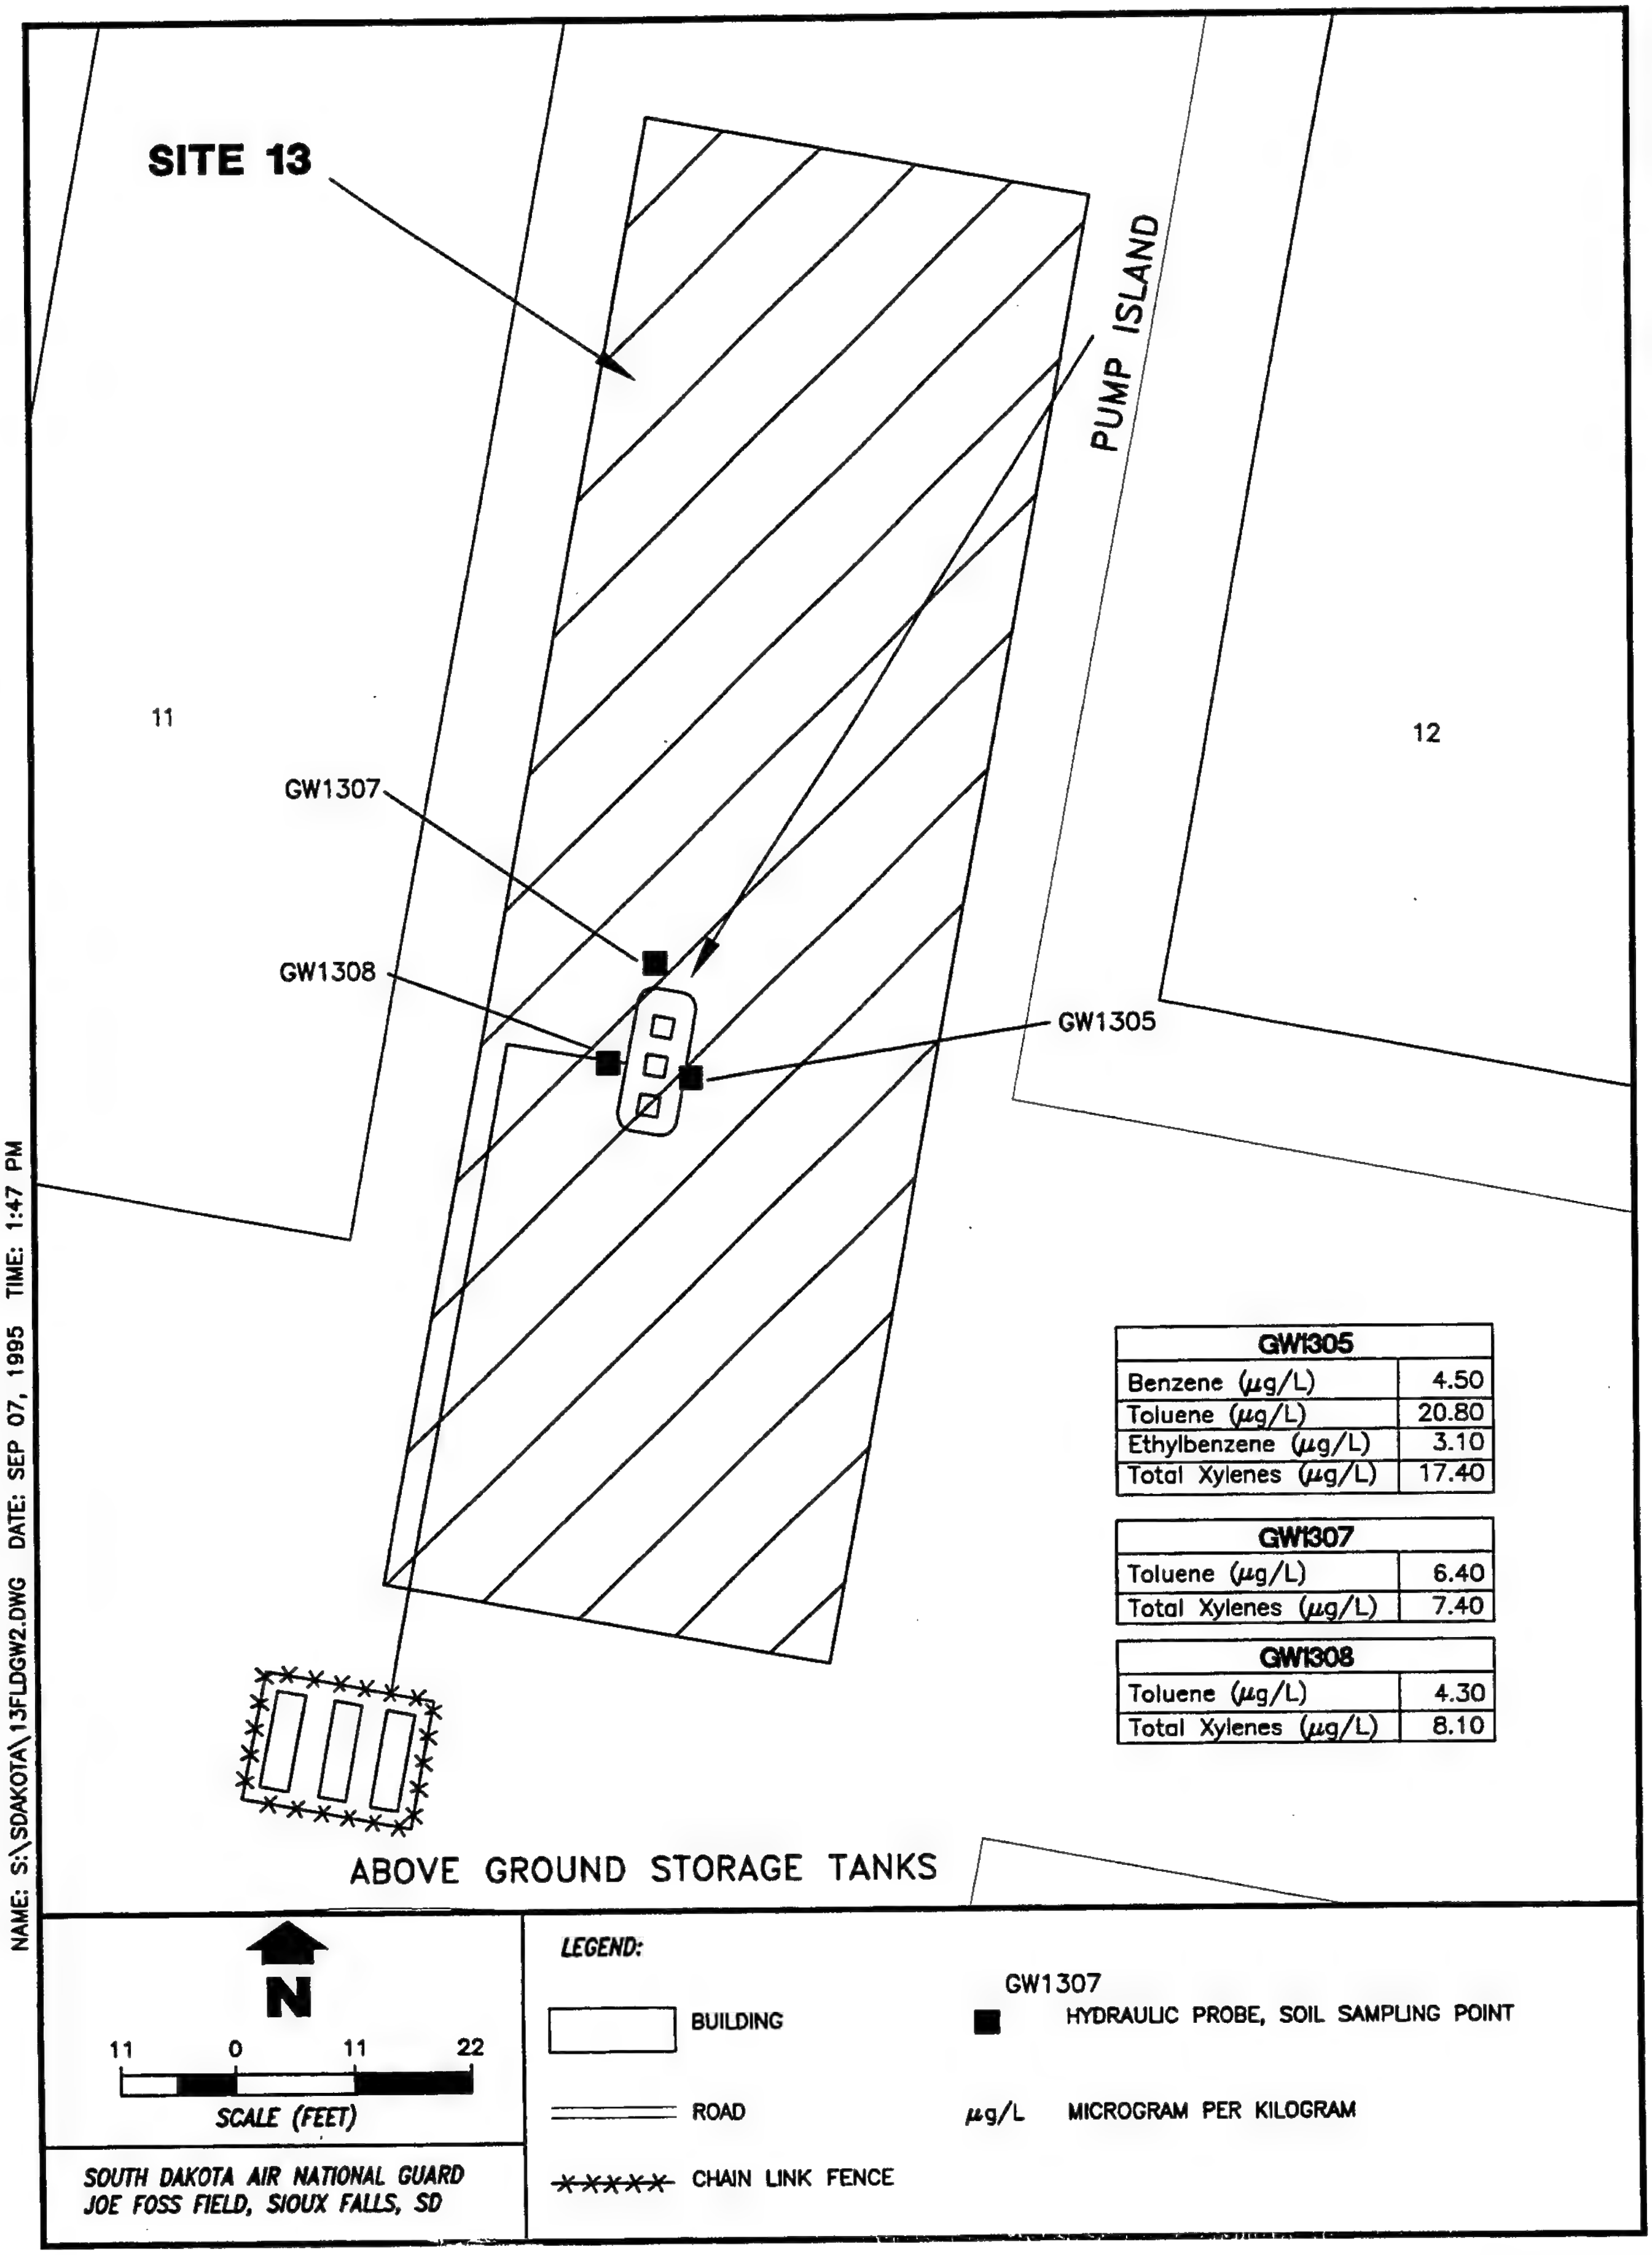
Contaminants at Site 13 were detected immediately surrounding the pump island. BTEX were detected at GW1305, approximately 9 feet due east of the pump island. The maximum concentration of any compound was 20.8 μg/L of toluene. Toluene and xylene also were detected at GW1308, immediately west of the pump island, and GW1307, immediately north of the island, as shown in Figure 5-4 and Table 5-5. VOCs and TPH were not detected in any other groundwater sample.

GW1305	
Benzene (µg/L)	4.50
Toluene (µg/L)	20.80
Ethylbenzene (µg/L)	3.10
Total Xylenes (µg/L)	17.40

GW1307	
Toluene (µg/L)	6.40
Total Xylenes (µg/L)	7.40

The Site 13 SI data indicate that isolated soil and groundwater contamination occur at levels below the South Dakota DENR cleanup standards and MCLs, respectively. Therefore, no further action is recommended for this site. A decision document recommending no further action should be prepared for Site 13.
